RESTORATION WORK

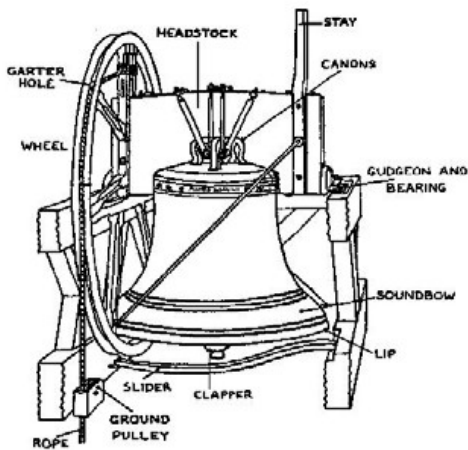
Our 8 bells had a local reputation of being 'difficult' and were in need of attention. In particular, the wooden frame supporting the bells needed strengthening or replacing, the bells themselves needed turning because of wear and worn clappers needed replacing. The five heaviest bells had wooden headstocks which needed to be replaced with cast iron and new steel gudgeons and the bearing housings needed new seals and ball races.

There were difficulties with ringing the 5th and 7th bells and ringing the heaviest bell, the tenor, causes undue movement and affects the chiming apparatus.

- The wooden oak frame needed to be strengthened or replaced
- The bells needed turning and tuning due to wear from the clappers
- The clappers needed replacing due to wear
- The five heaviest bells had wooden elm headstocks. These have weaknesses and needed replacing with cast iron ones
- There was wear to the gudgeons, the spindles on which the bells rotate and movement where the gudgeons were

- supported. New headstocks would be complete with new steel gudgeons.
- The bearing housings needed new seals and ball races.

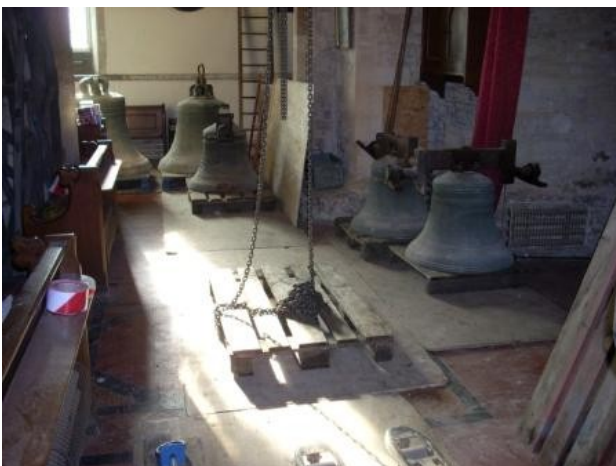
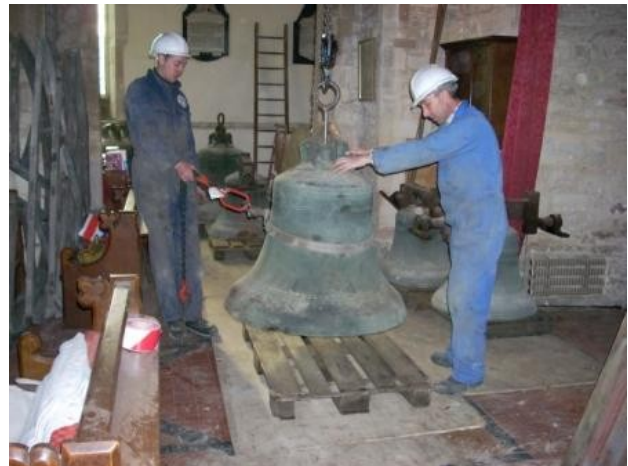
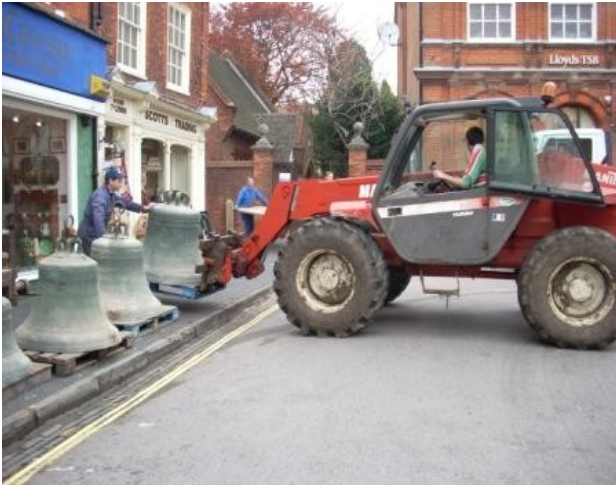
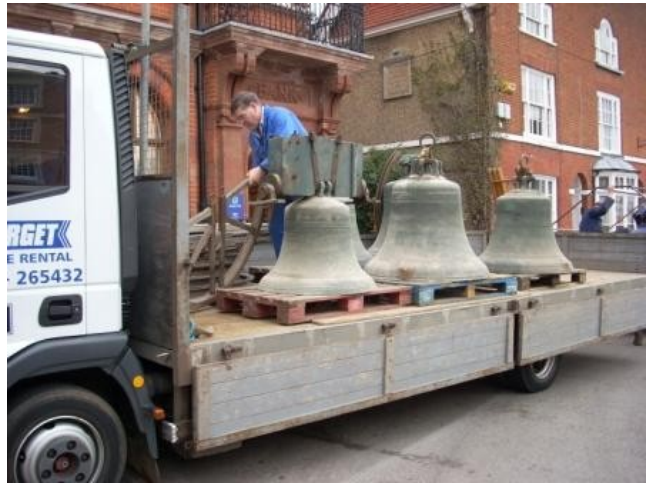
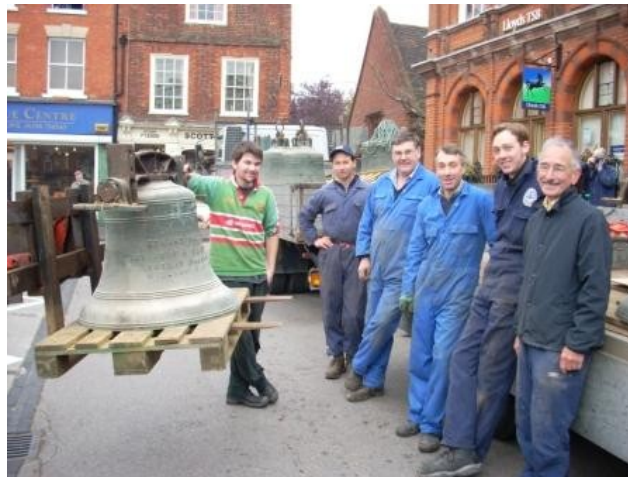
This work required removing the bells and transporting them to the bell hangers' workplace. Beginning in 2005, almost £60,000 was raised by the group of bellringers through fundraising and grants to allow work to begin at the end of October 2007- see pictures below of them being removed from the tower.

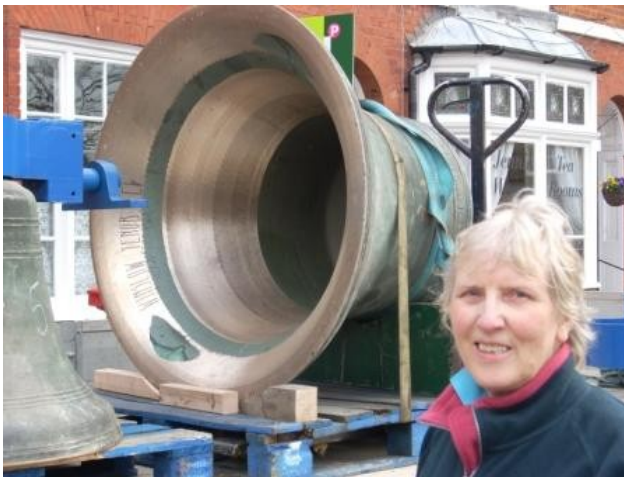
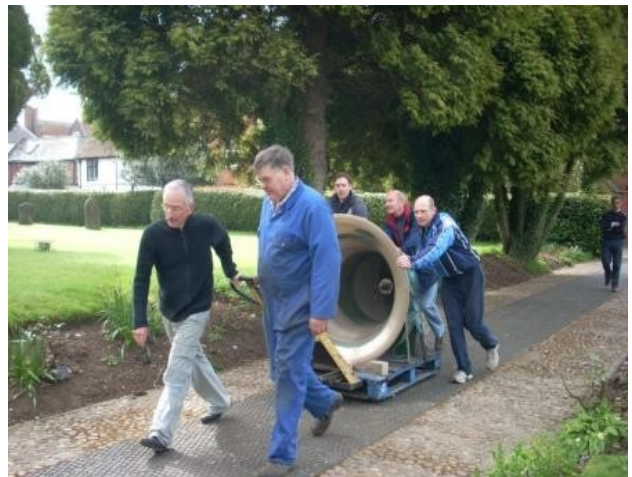
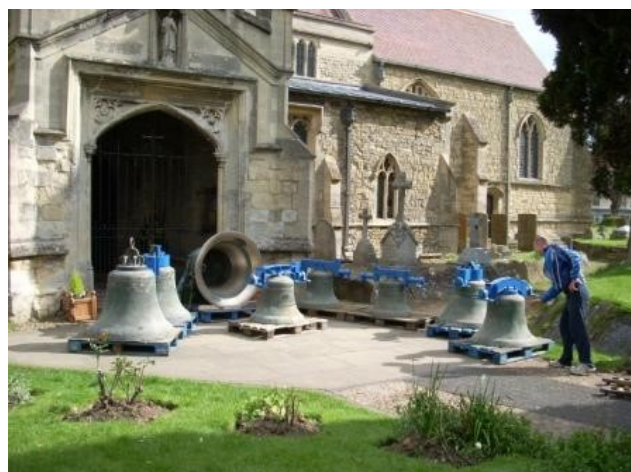
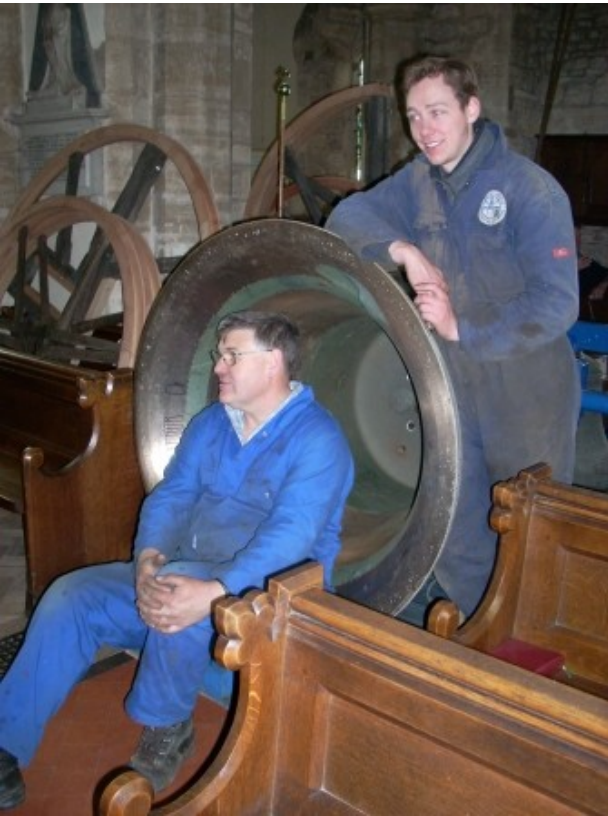
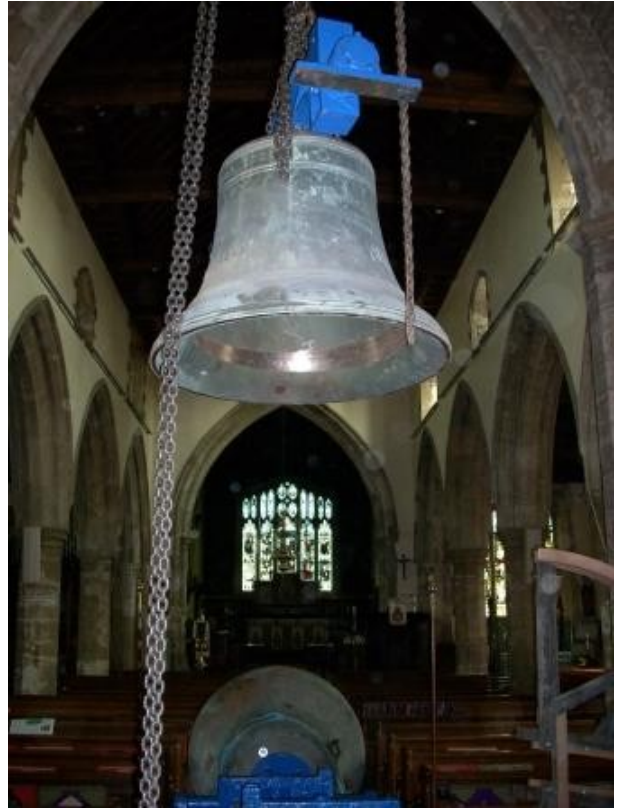
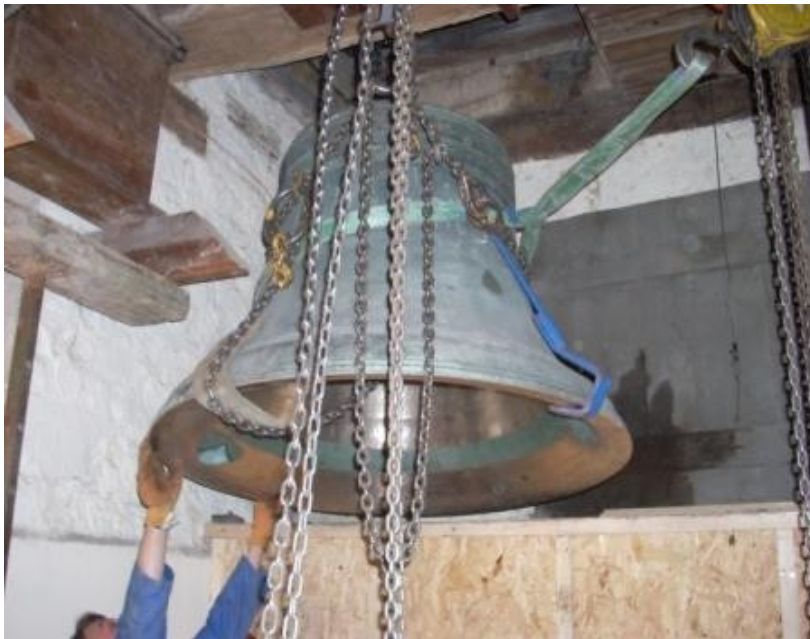
... and now some pictures of the return of our bells after repair and retuning in May 2008.
